SECTION 32 PROGRAM
STREAMBANK EROSION CONTROL
EVALUATION AND DEMONSTRATION
WORK UNIT 2 - EVALUATION OF EXISTING
BANK PROTECTION
INSPECTION OF SITES IN ALBUQUERQUE DISTRICT

Malcolm P. Keown

November 1977

Inspection Report 3

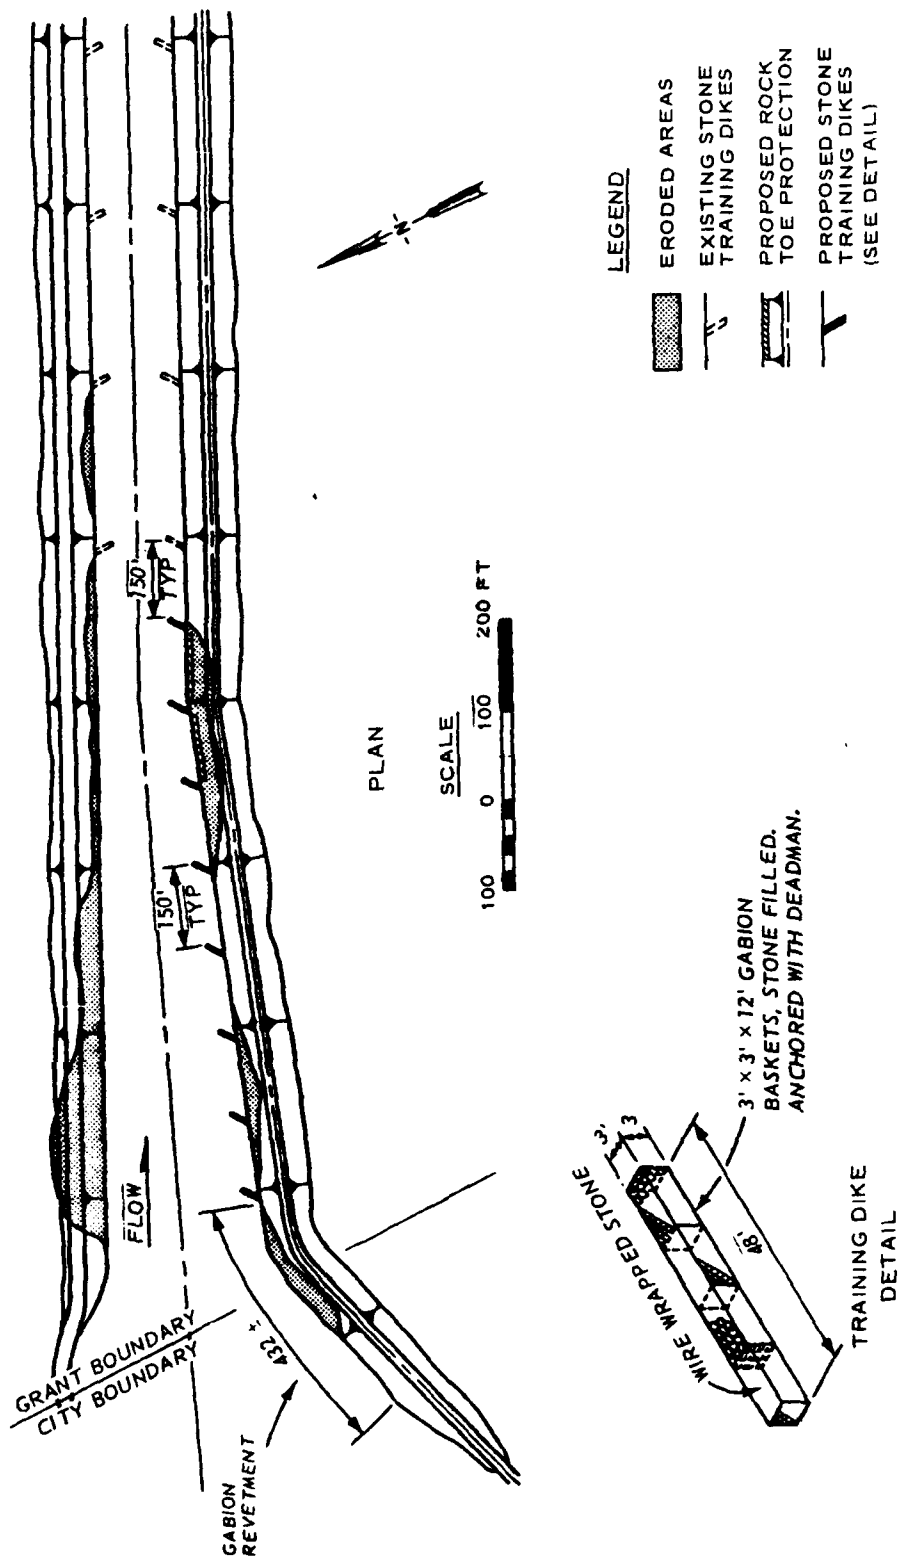
9. Before repairs of the 1975 flood damage, another 15,000-25,000 cu yd of levee erosion occurred in the September 1976 flood. In October 1976 and April 1977 the south levee was repaired. The now completed work includes: (a) placement of compacted fill secured from the channel bed in the eroded areas of the levee (Figure 6), (b) placement of rock-fill protection in selected portions of the restored levee, (c) completion of the gabion revetment installation on the west end of the levee (Figure 7), and (d) installation of eight training dikes between the existing training dikes and the gabion revetment installation. A project map for this work is shown in Figure 8. Federal and local participation costs were \$38,000 and \$22,000, respectively. Land use re-evaluation of the area behind the north levee indicated that there was nothing of value to protect; therefore no efforts were made to protect this levee, thus allowing the creek width to expand and reduce flow concentrations along the south levee.

Figure 8. Project map for work completed in 1977

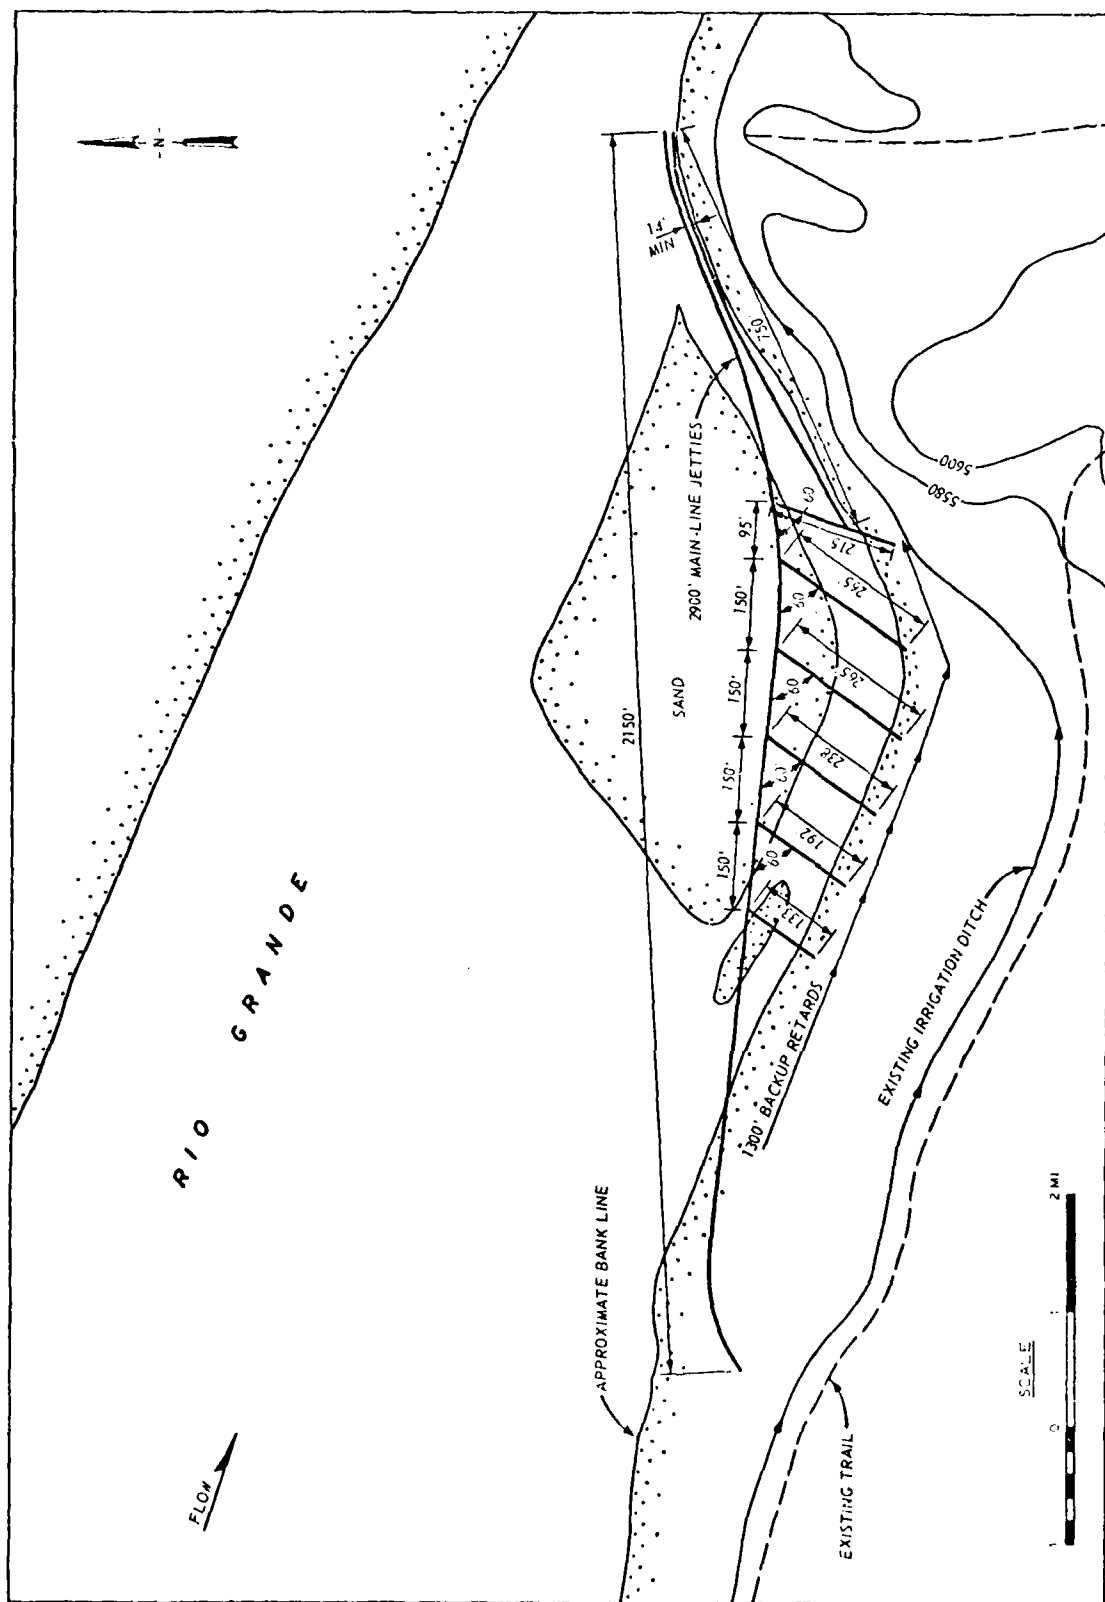
F. D. Shufflebarger, Inc. (Albuquerque) installed 4,313 lineal feet of permeable jetties (Kellner Jack Field) in 1951 (Figures 11 and 12). This installation consists of two main-line jetties (2,900 and 700 ft in length) and six backup retards varying from 133 to 265 ft in length. The jack units consist of three linear members (each being 15 ft in length) bolted together at their midpoints such that each member is perpendicular to the other two. The members are laced with #10 steel wire; the jack units are connected with cable (Figure 13). The Bureau of Indian Affairs sponsored this project at a funding level of \$24,108 (1951 dollars).

Figure 11. Project map for the Kellner Jack Field installed in 1951
